**Topic:** NIC Sporadically Absent from Device Manager on R3080D PC Blade  
**Component(s) Affected:** R3080D PC Blade, Windows 7 Operating System  
**Date:** February 22, 2011

TB00263 Rev A

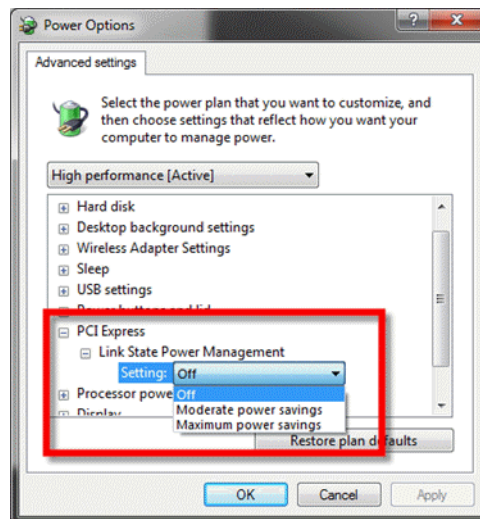
An R3080D's primary NIC can be sporadically removed from the Device Manager. In this scenario, the operating system does not detect the blade's primary NIC. As described in the following section, you can eliminate this issue by changing PCI Express™ power management options. This behavior is the result of a known issue with PCIe™ logic in the Intel® 82574 Gigabit Ethernet Controller, described in errata number 20 in *Intel 82574 Family Gigabit Ethernet Controller Specification Update, February 2011, Revision 3.3*.

1. Ensure that the R3080D blade is powered on. From the **Start** menu, click **Control Panel > Hardware and Sound > Power Options**.
2. Select any power plan (you must perform this procedure on all power plans) and click **Change Plan Settings > Change advanced power settings** to display the Power Options dialog box.
3. Expand the **PCI Express** item and select **Off** from the drop-down menu.

4. Click **Apply** and then click **OK**.
5. As noted above, change the PCI Express Link State Power Management option to Off for all of the blade's power plans.
