**Topic:** Incorrect USB Power Settings Cause C/Ports to Lose Connectivity  
**Component(s) Affected:** R1300, R1350, R3040S, R3080D PC Blades; C/Port; Disk Images  
**Date:** February 21, 2011

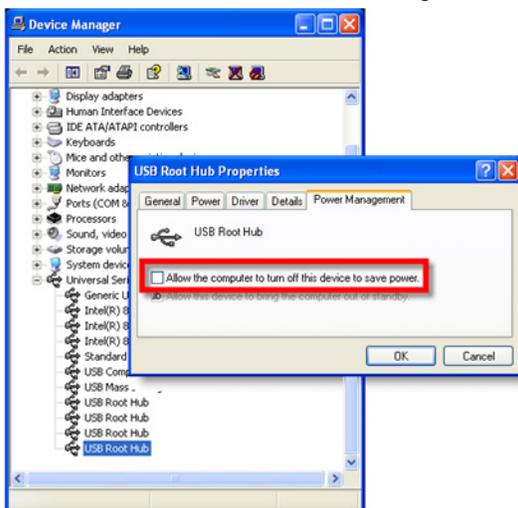
Windows XP

In most cases, these problem are symptomatic of improper USB power management settings in the operating system Control Panel. This section describes a temporary workaround (note that Control Panel settings are not the root cause of the issue).

1. Restart the blade locally (press the blade's front panel Restart button).
2. From the operating system Device Manager (available from the Control Panel's **System** area), disable all USB root hub power management. Open the root hub properties dialog box and clear the **Allow the computer to turn off this device to save power** option and click **OK**. Perform this step for all USB root hubs listed in the Device Manager.
